**Flood Control Project Maintenance
Levee Inspections**

Fall 2018 Levee Maintenance Deficiency Summary Report

**Flood Control Project Maintenance
Levee Inspections****LMA District Cover Sheet****Fall 2018 Levee Inspection Results****Reclamation District No. 0341 Sherman Island**

Reclamation District No. 0341 Sherman Island

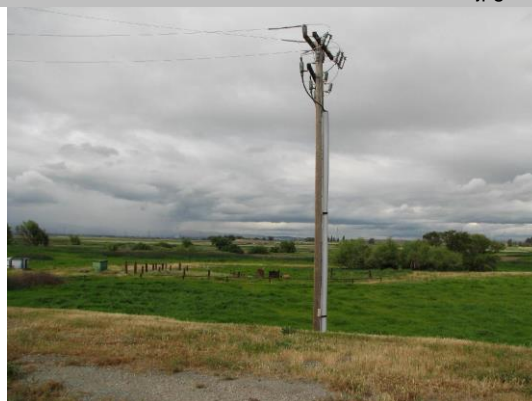
Photo 3 of 3 : UCIP_FA_2018_52253_37645.jpg

Power pole located on LS aligns with crossing.

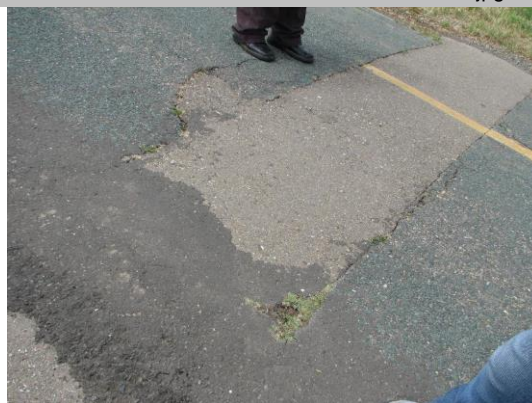
Photo 1 of 3 : UCIP_FA_2018_52254_37654.jpg

Cut along pipe alignment--unknown repair or maintenance date.

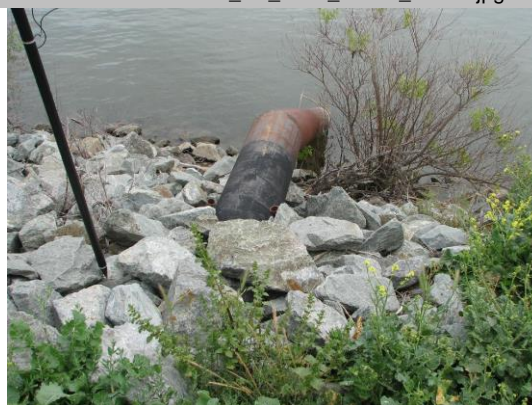
Photo 1 of 3 : UCIP_FA_2018_52255_37664.jpg

View of pipe located on WS.

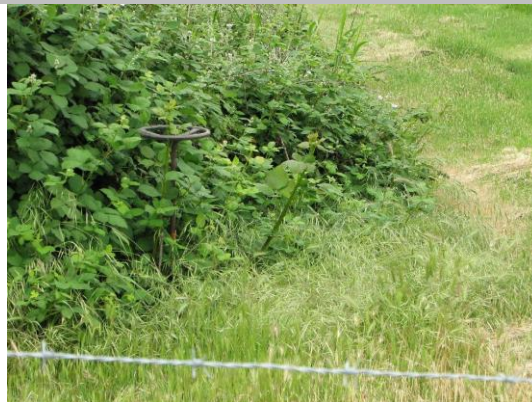
Photo 3 of 3 : UCIP_FA_2018_52255_37662.jpg

Gate located past the fence area near LS toe.

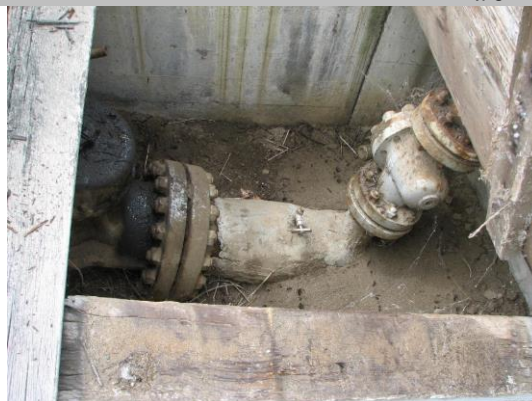
Photo 2 of 3 : UCIP_FA_2018_52256_37672.jpg

Inside view of vault located on the LS.

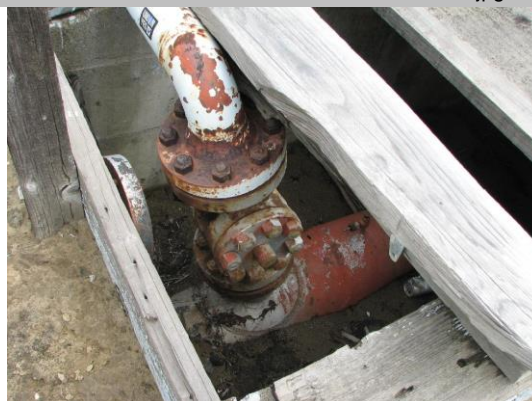
Photo 3 of 3 : UCIP_FA_2018_52256_37674.jpg

View of pipe inside concrete box located on LS.

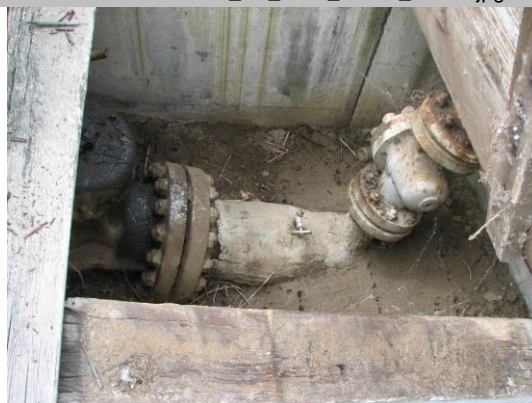
Photo 2 of 3 : UCIP_FA_2018_52257_37677.jpg

Inside view of vault located on the LS.

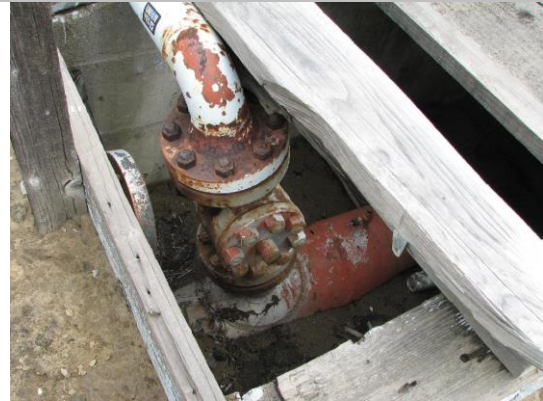
Photo 3 of 3 : UCIP_FA_2018_52257_37679.jpg

View of pipe inside concrete box located on LS.

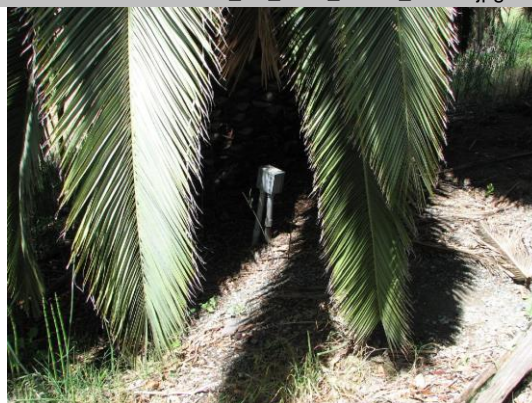
Photo 2 of 3 : UCIP_FA_2018_52258_37704.jpg

Power connection on WS no other appurtenances found.

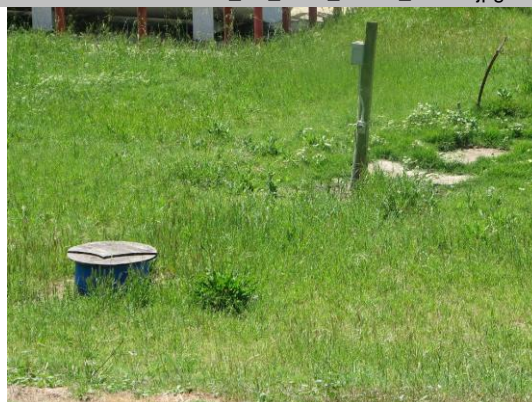
Photo 2 of 3 : UCIP_FA_2018_52259_37711.jpg

LS view: sump pump inside drains to leach field.

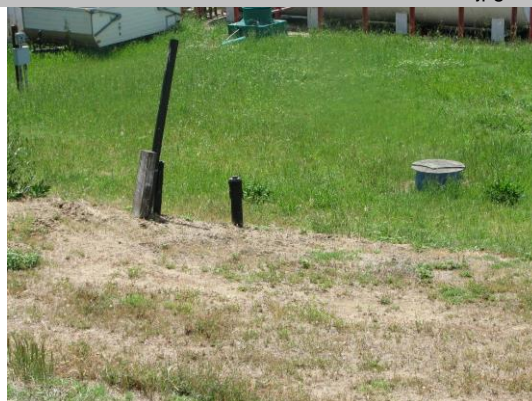
Photo 1 of 2 : UCIP_FA_2018_52260_37717.jpg

Electrical conduit and box located on left corner of picture.

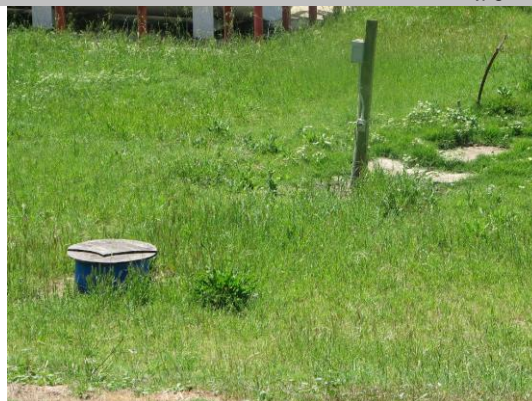
Photo 2 of 2 : UCIP_FA_2018_52260_37716.jpg

Electrical connection visible next to sump pump--right corner.

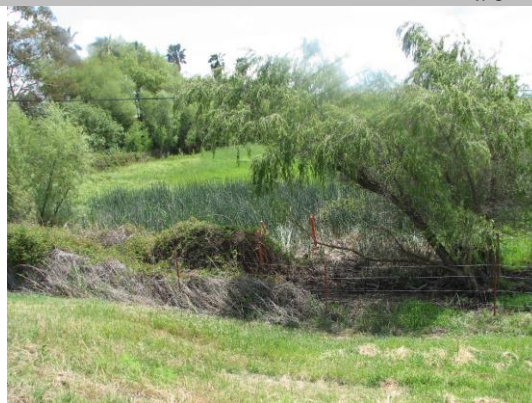
Photo 2 of 2 : UCIP_FA_2018_52261_37718.jpg

LS markers visible near levee toe.

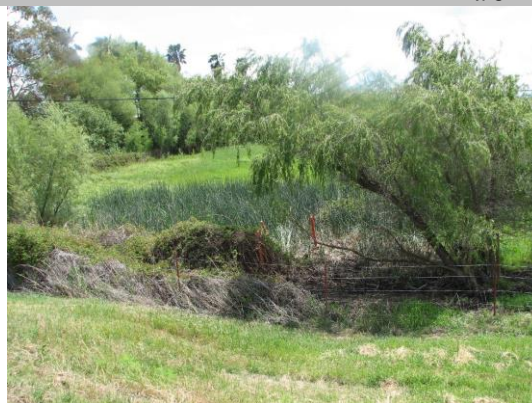
Photo 2 of 2 : UCIP_FA_2018_52262_37723.jpg

Markers also visible on LS near levee toe.

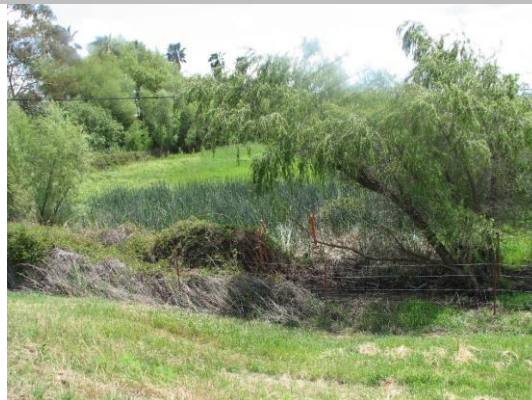
Photo 2 of 2 : UCIP_FA_2018_52263_71846.jpg

Markers visible on LS toe.

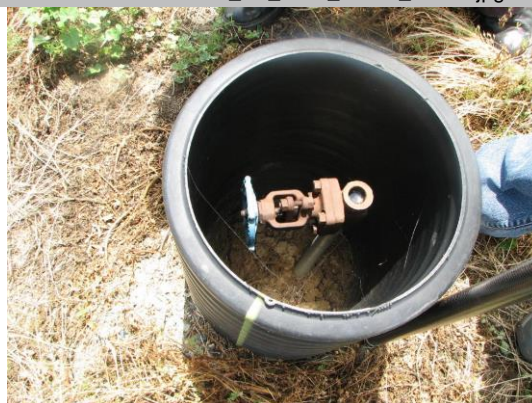
Photo 3 of 3 : UCIP_FA_2018_52264_37732.jpg

Primer stem located on LS slope.

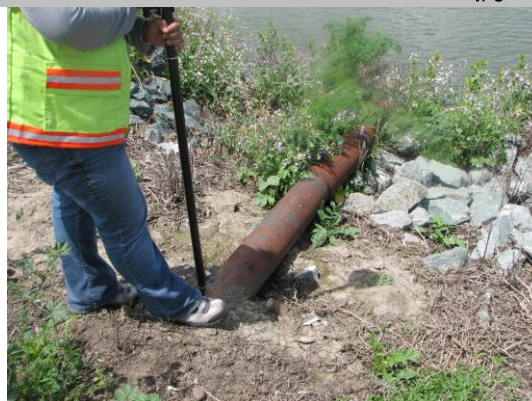
Photo 1 of 3 : UCIP_FA_2018_52265_37750.jpg

View of pipe and rip rap located on WS.

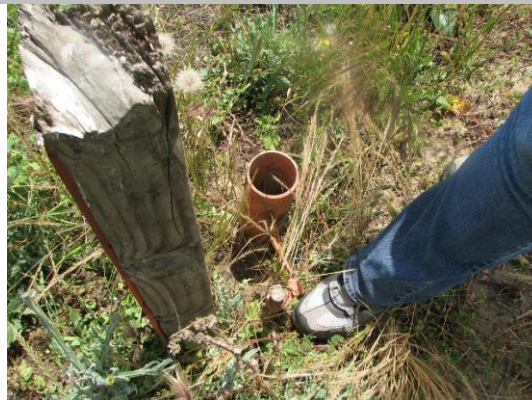
Photo 2 of 3 : UCIP_FA_2018_52265_37747.jpg

Small stand pipe (primer) located on LS--unknown purpose of stand pipe.

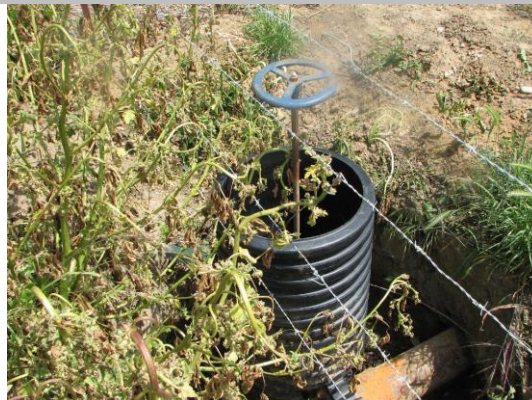
Photo 3 of 3 : UCIP_FA_2018_52265_37749.jpg

New distribution box and valve located on LS.

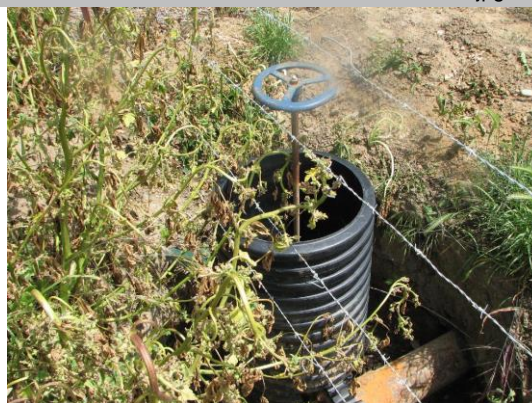
Photo 3 of 3 : UCIP_FA_2018_52266_37757.jpg

New distribution box and valve located on LS.

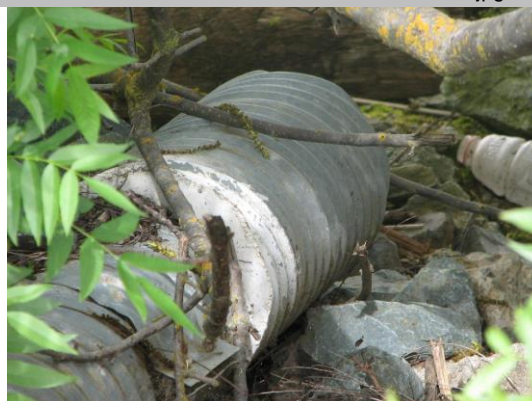
Photo 3 of 3 : UCIP_FA_2018_52267_37781.jpg

View of corrugated metal pipe on WS.

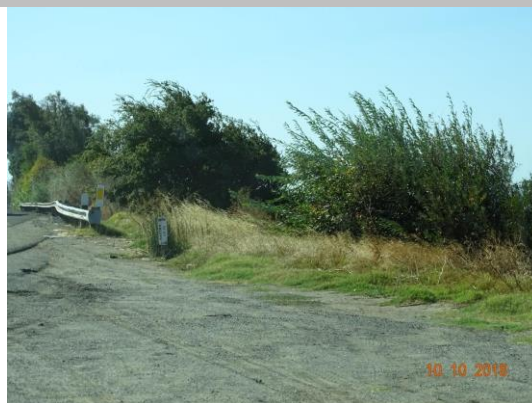
Photo 1 of 2 : FA_2018_RD0341_168_41_20181011_00081.jpg

Vegetation looking downstream at the beginning of where the levee is on Highway 160 (October 2018).

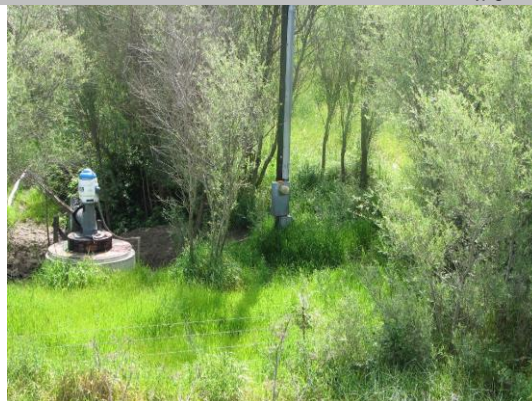
Photo 3 of 3 : UCIP_FA_2018_22203_37835.jpg

View of well and pump located on landward side.

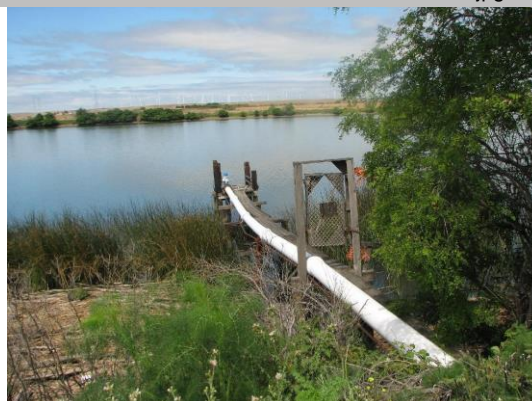
Photo 1 of 1 : UCIP_FA_2018_22223_37840.jpg

View of waterward side--pipe and pump visible.

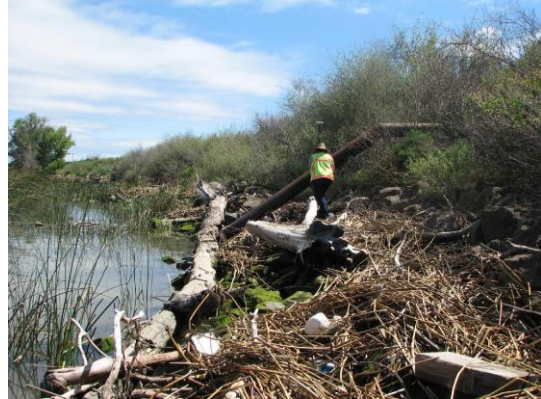
Photo 1 of 3 : UCIP_FA_2018_53343_37842.jpg

View of crossing on waterward side. Dense vegetation limits inspection of crossing.

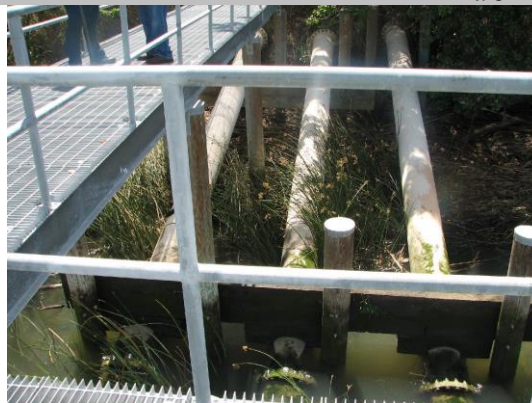
Photo 2 of 3 : UCIP_FA_2018_22253_37882.jpg

View of waterward side - 3-20 inch pipes.

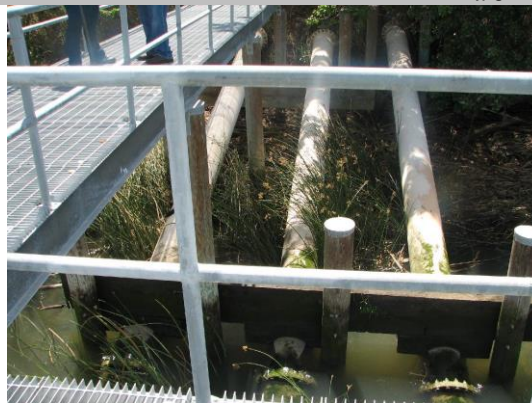
Photo 2 of 3 : UCIP_FA_2018_22254_37898.jpg

View of waterward side - 3-20 inch pipes.

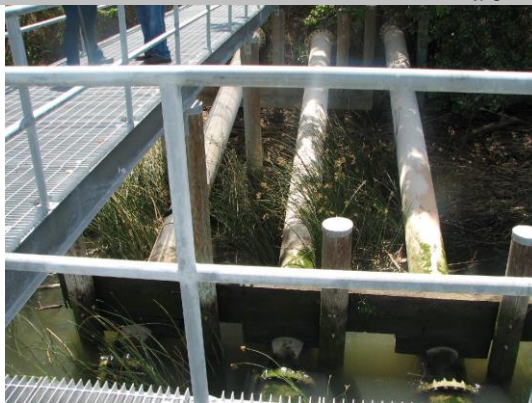
Photo 2 of 3 : UCIP_FA_2018_22255_37909.jpg

View of waterward side - 3-20 inch pipes.

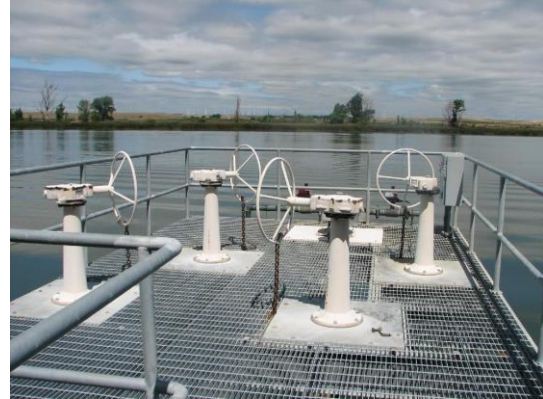
Photo 3 of 3 : UCIP_FA_2018_22255_37908.jpg

Gates located on waterward side.

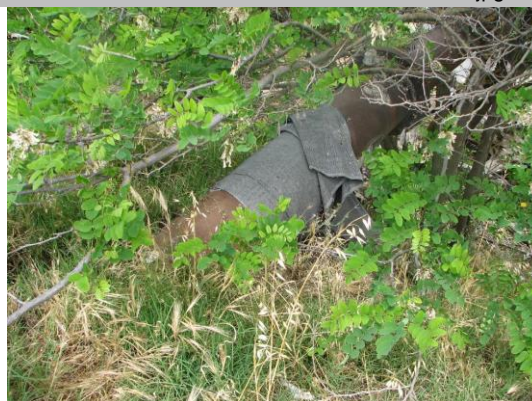
Photo 3 of 3 : UCIP_FA_2018_22256_37917.jpg

Pipe on waterward side at daylight.

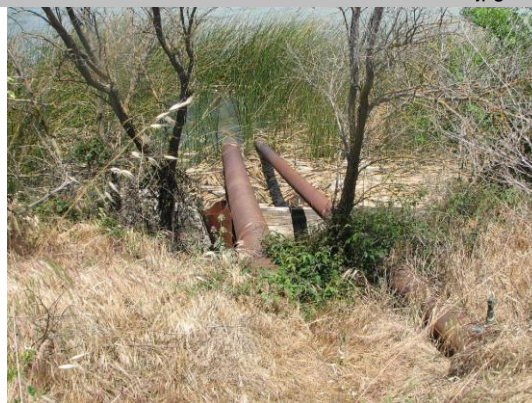
Photo 1 of 3 : UCIP_FA_2018_22258_37932.jpg

8-inch pipe and 14-inch pipe on waterward side.

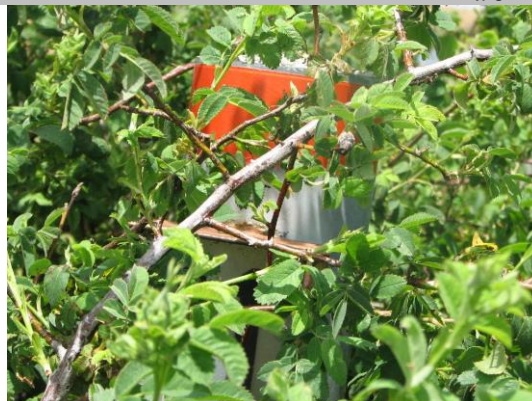
Photo 2 of 3 : UCIP_FA_2018_39861_71852.jpg

Marker visible on waterward side associated with crossing.

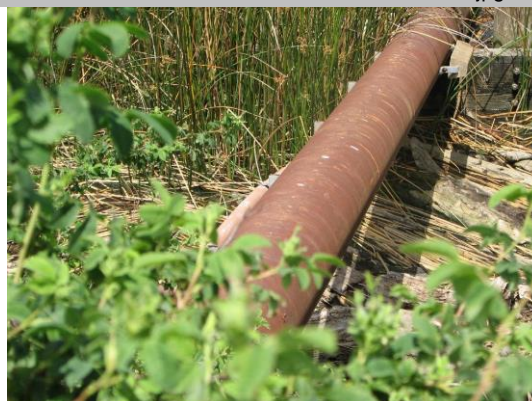
Photo 3 of 3 : UCIP_FA_2018_39861_71851.jpg

Pipe section visible on waterward side.

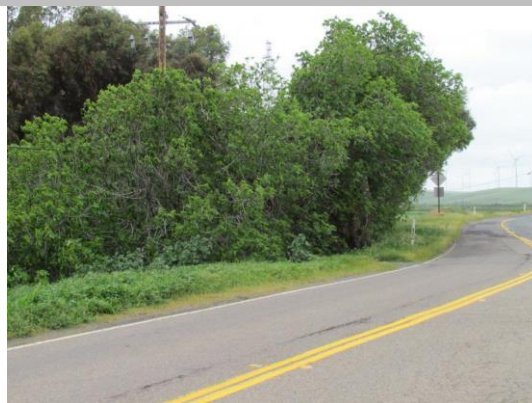
Photo 1 of 1 : FA_2018_RD0341_168_47_20180925_00009.jpg

RD 341 landside levee slope mile 6.29-6.32.

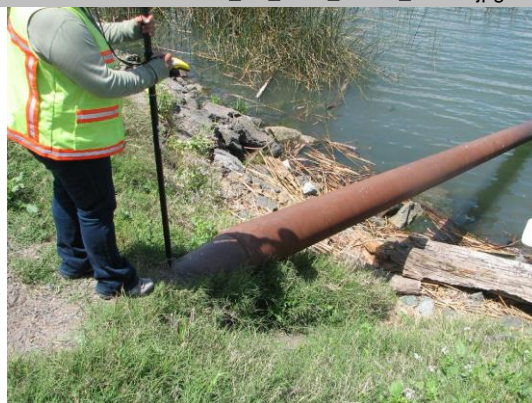
Photo 2 of 3 : UCIP_FA_2018_22261_37947.jpg

View of pipe and rip rap on waterward side.

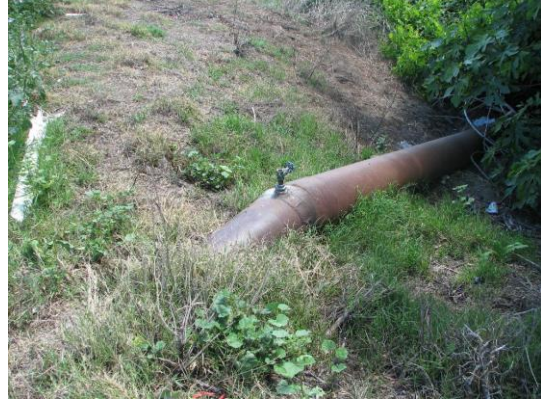
Photo 3 of 3 : UCIP_FA_2018_22261_37948.jpg

View of crossing on landward slope.

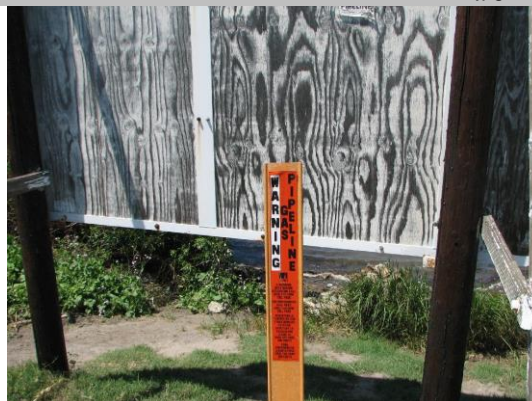
Photo 2 of 2 : UCIP_FA_2018_22267_37977.jpg

Marker located on waterward side.

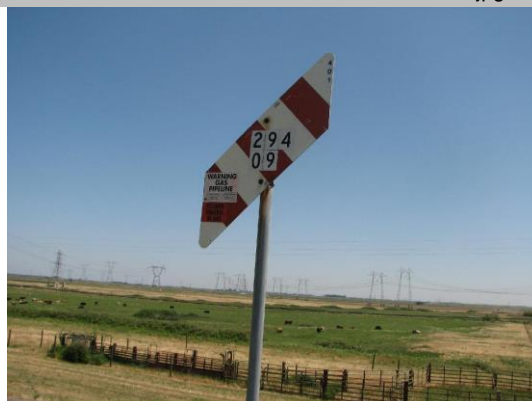
Photo 1 of 2 : UCIP_FA_2018_22268_37980.jpg

Utility marker located on landward side.

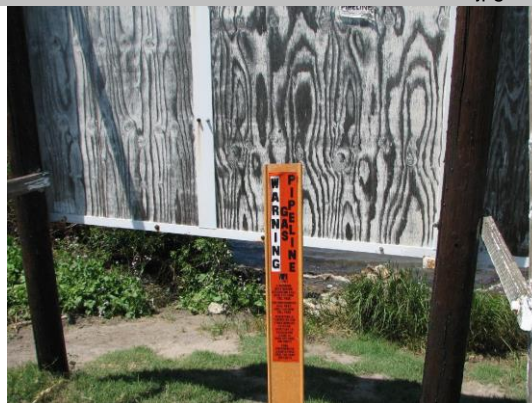
Photo 2 of 2 : UCIP_FA_2018_22268_37979.jpg

Utility marker located on waterward side.

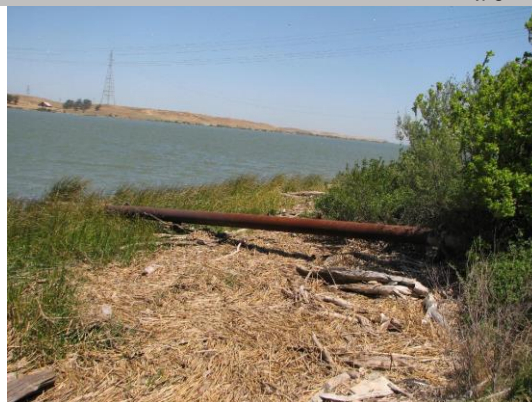
Photo 2 of 3 : UCIP_FA_2018_22293_38040.jpg

View of crossing located on waterward side.

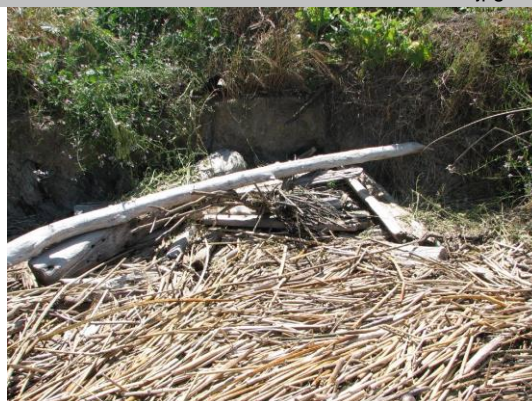
Photo 3 of 3 : UCIP_FA_2018_22293_38044.jpg

Concrete headwall found on waterward side.

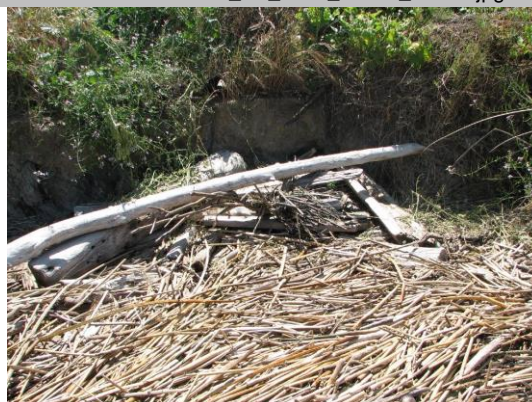
Photo 2 of 3 : UCIP_FA_2018_22294_38050.jpg

Concrete headwall located on waterward side.

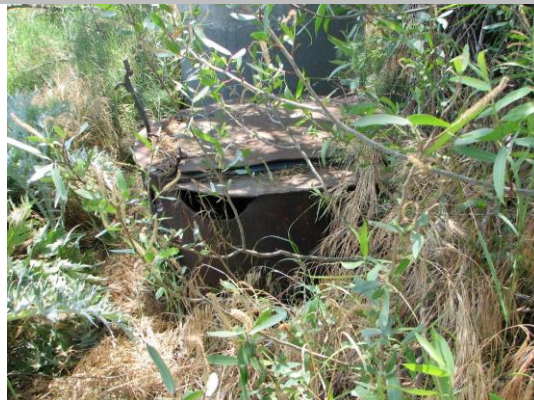
Photo 3 of 3 : UCIP_FA_2018_22294_38047.jpg

Steel stand pipe located on landward side near levee toe.

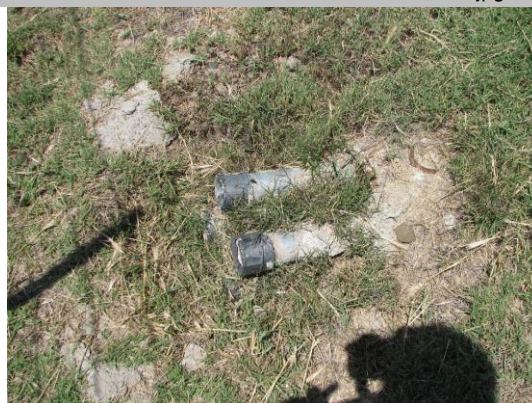
Photo 3 of 3 : UCIP_FA_2018_22303_38060.jpg

View of conduit on landward side. Four 2.5-inch conduits through levee not in use yet.

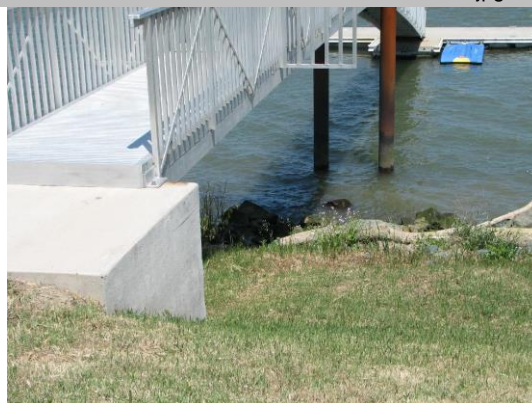
Photo 1 of 1 : UCIP_FA_2018_22305_38064.jpg

Dock installed at levee mile 7.91.

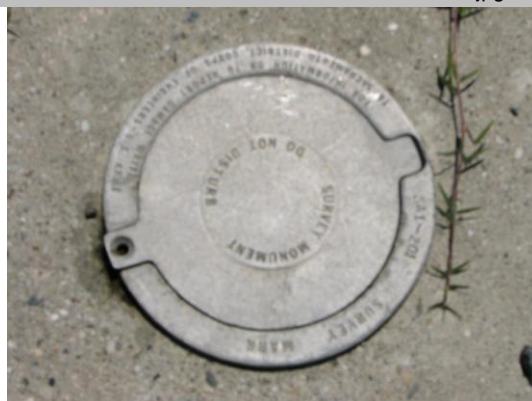
Photo 1 of 3 : UCIP_FA_2018_22306_38067.jpg

Survey marker found at this location.

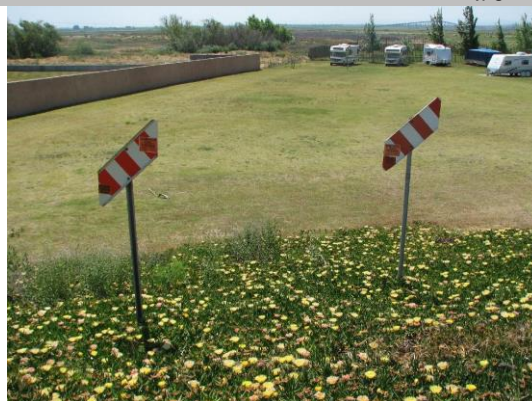
Photo 2 of 3 : UCIP_FA_2018_22306_38066.jpg

Gas line markers visible on landward side.

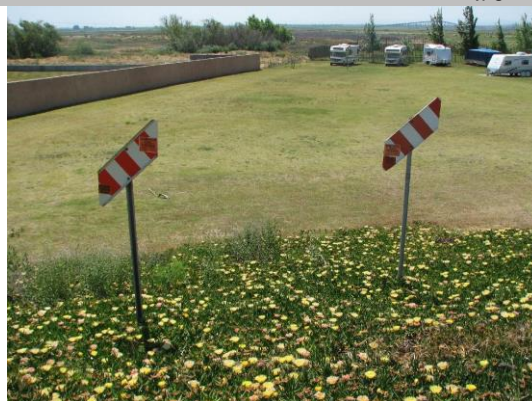
Photo 2 of 3 : UCIP_FA_2018_22307_38069.jpg

Gas line markers located on landward side.

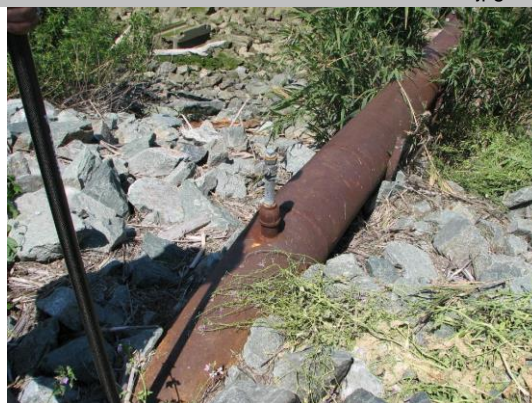
Photo 3 of 3 : UCIP_FA_2018_22309_38077.jpg

Siphon breaker visible on waterward side. Levee toe is armored with rock slope protection.
